# **Intel<sup>®</sup> Mobile Pentium<sup>®</sup> II Processor Specification Update**

Release Date: August 2000

Order Number: 243887-023

The Mobile Pentium<sup>®</sup> II processor may contain design defects or errors known as errata which may cause the product to deviate from published specifications. Current characterized errata are documented in this Specification Update.

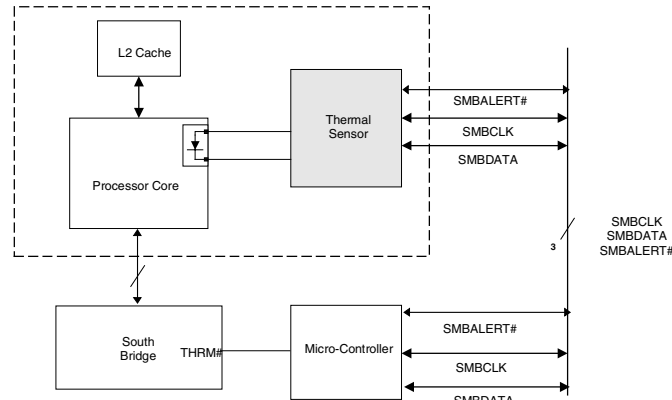
**Figure 1. An Example of Microcontroller Driven Thermal Management**

### B30. Thermal Sensor May Assert SMBALERT# Incorrectly

**Problem:** The Mobile Pentium II processor and the Pentium II Processor Mobile Module have a thermal sensor that monitors the processor core's temperature. Please note that desktop systems could have a similar thermal device. The thermal sensor asserts SMBALERT# if the processor temperature exceeds the temperature limits set in the Alarm Threshold Registers ( $T_{HIGH}$ ,  $T_{LOW}$ ). It also sets the corresponding Status Register bits to identify the cause of the interrupt. Figure 1 gives one example of the how the SMBALERT# signal could be used in a system.

Under the conditions described below, the thermal sensor incorrectly generates the SMBALERT# interrupt. All of the following conditions must be met to trigger a false interrupt:

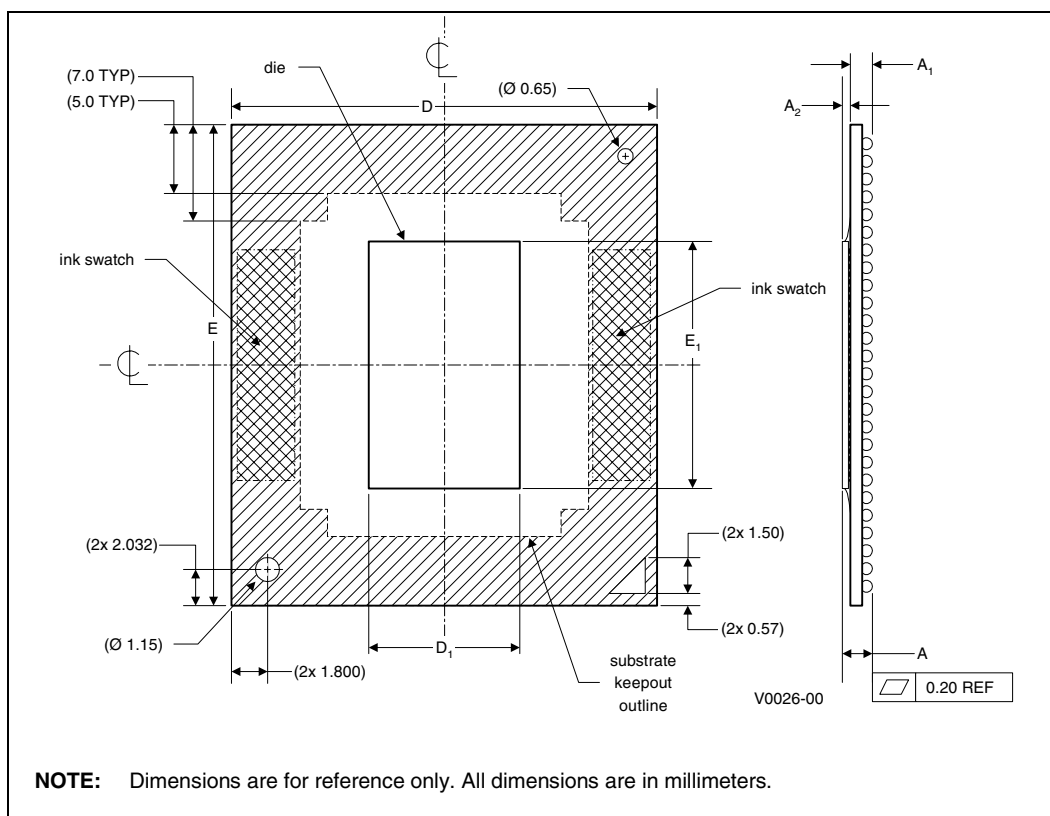
**Figure 5.3. Surface-Mount BGA1 Package—Top and Side View**

The following table and figures show the updated mechanical specifications for the BGA1 package, listed as Table 5.2, Figure 5.3 and Figure 5.4, respectively, in the *Mobile Pentium® II Processor in BGA Package at 366 MHz, 333 MHz, 300PE MHz, and 266PE MHz* datasheet.

1. The number shown here is different from that in the 243887-010 revision of this specification update. The maximum reference number is used.

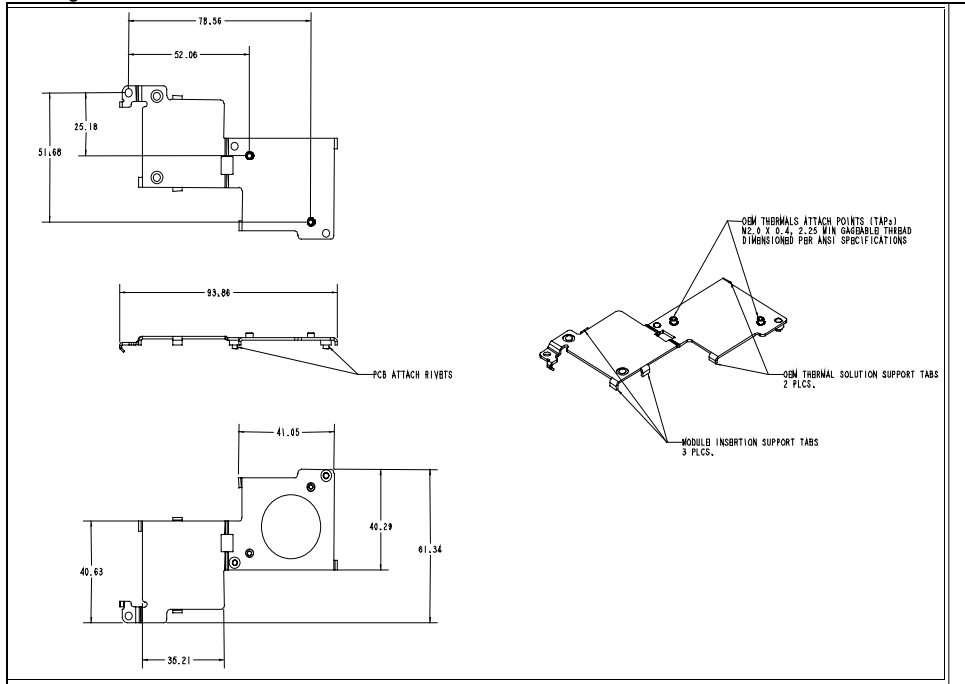
Figure 1. TAP Gageable Thread Clarification

OEM Thermal Attach Points (TAPs) M2.0 x 0.4, 2.25 min gageable thread dimensioned per ANSI specification.

See Figure 1 below for more information.
